Anatomy of a Hydraulic Failure

Hydraulic Fittings Need to be Very Carefully Tightened

(Rev. 2, 3 June 2010)

Fred Moreno, Chris Howden (SAAA Chapter 13)
Laurie Fitzgerald (SAAA Chapter 24)

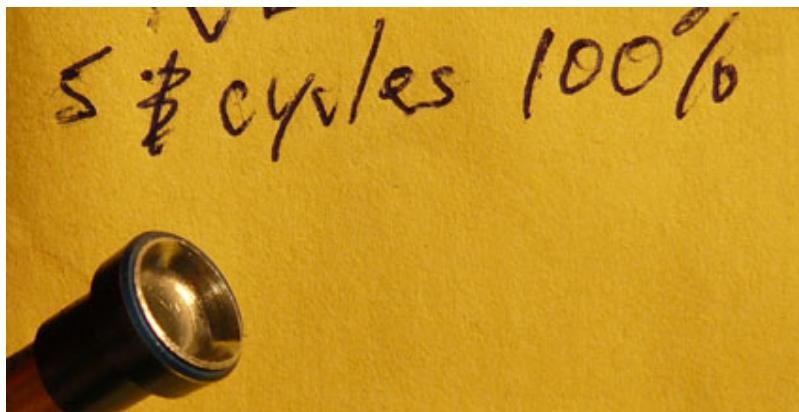
Proper flare tested with five cycles at 100% of recommended torque

After five cycles, the flared tube end appears slightly more polished, but the flare is not deformed or thinned in any way. Repeated cycling did not damage the flare.

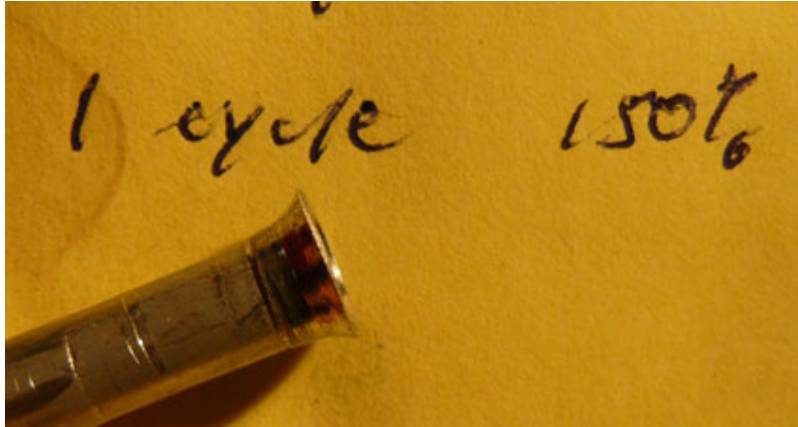
Tube flare after one cycle at 150% of recommended torque

While difficult to see in the photo, inspection with a magnifying glass showed that only one cycle at 150% torque was adequate to deform the flare, thinning the flare wall, and extruding metal toward the periphery which was now much thinner and starting to approach a knife edge. Clearly one cycle of torque overload had extruded the aluminium outward and permanently deformed the flare.

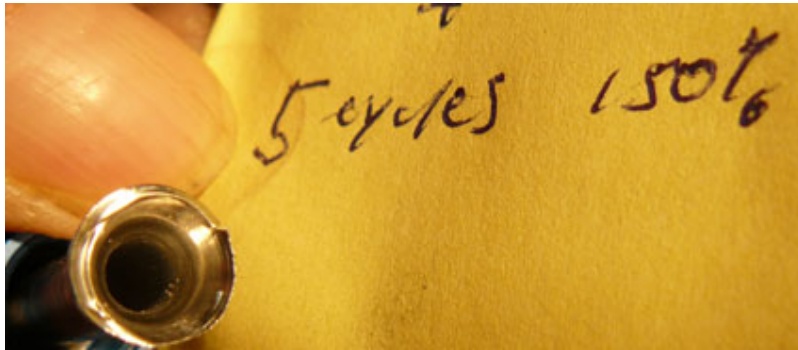
Tube flare after five cycles at 150% of recommended torque

By the end of the fifth overload cycle, the tube flare wall was substantially thinned with much material extruded out the top of the flare where it formed a knife edge and interfered with the internal threads of the nut. To get the nut off we had to pull hard which bent that portion of the knife edge which is the upper half of the tube flare in the photo above. Clearly this flare is well on its way to failure.

The smaller diameter aluminium tubing and 37 degree flare fittings we use on our aircraft for brakes and hydraulic lines is **very sensitive to extrusion by over tightening** of the AN818 nut. It only takes a onetime 50% overload to damage the tubing flare. A few cycles of overload at less than 50% excessive torque can compromise the strength sufficiently that a flare which may be appear to be in good condition can fail when hydraulic pressures are applied.

Always use a torque wrench when tightening your flare fittings, particularly the ¼ inch size. Buy a set of crow feet so that you can put your torque wrench on your AN818 nuts. Treat these parts gently, and DO NOT make it “just a little tighter just to make sure.” Do it too often and inadvertently you will make sure that you end up with a hydraulic line failure.
