# The Outback Gear and Drag

9-29-2009, C.Zavatson

In the on-going effort to reduce drag, the focus turns to an issue unique to the outback gear seen on the Lancair 320/360.

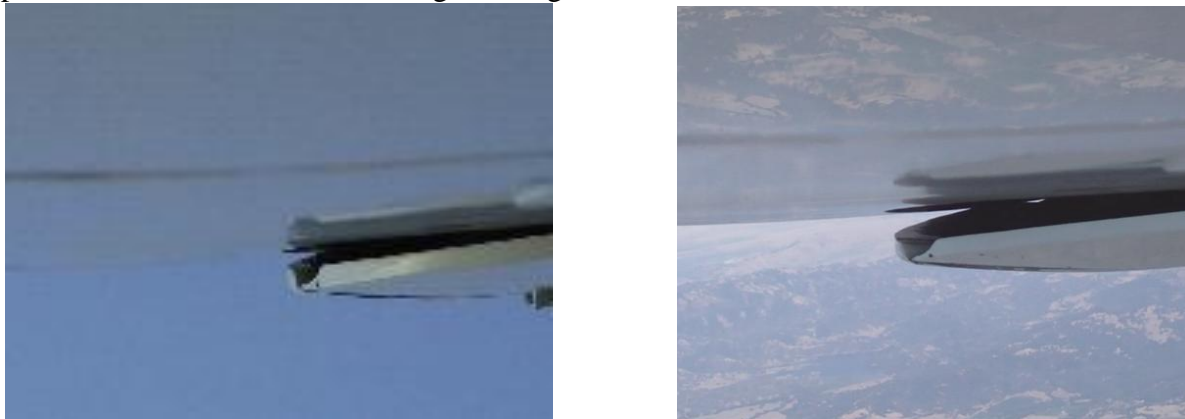
Figure 2, Original Outback Gear Doors on two different Lancair 360s

Unfortunately the larger areas, long moments and the flexible fiber glass materials all contribute to the rear of the outback doors opening in-flight. The leading edge might remain retracted, but the door itself twists under load. Simply giving the doors a good yank on the ground reveals their flexibility. Air to air photos show this phenomenon, but getting a really close up view provides much more detail. In-flight footage shows the results of air flow over the door.

While open doors are not a safety issue, it represents an area of improvement in efficiency. They are a drag penalty for having such a large gap open up.

Prior to replacing the doors with a new design, a series of exploratory tests were conducted. The purpose was to isolate the source of the forces involved. The wheel well was completely sealed from the cabin. A bellows boot sealed the aileron pushrod and a composite cover was installed over the inner gear door cylinder. Next, the wheel well pressure was measured relative to ambient. This measurement revealed a strong negative pressure, indicating the doors were being pulled down by external low pressure rather than being pushed down by internal high pressure. Flow separation (and lack of pressure recovery) on the rear half of the doors was also eliminated as a root cause or contributing factor by tufting this area. The flow remained fully attached. The trailing edges of the original doors deflect downward through a twisting of the door itself. The degree of deflection is proportional to indicated airspeed, more speed equals more deflection. At cruise speed this can be on the order of an inch at the trailing edge.

The approach used to solve this problem was to utilize a three piece design and improve the stiffness of the doors themselves. The new doors are made of carbon. They are geometrically identical to the original doors but have greatly increased stiffness. The new inner gear door is about half the size of the original. This enables it to exert much greater vertical force on the overlap with the center door. The center door is attached to the main gear trailing link arm using four stand-offs. A new trailing link arm was fabricated to provide mounting tabs for the new door. The wide mounting foot print provides a solid base which further adds stiffness.

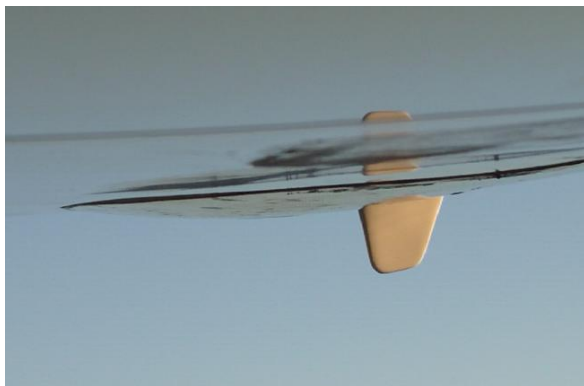
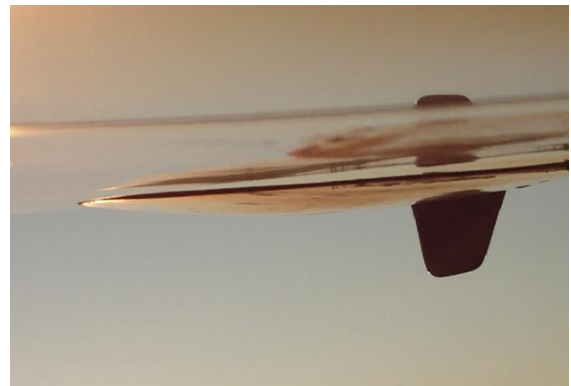
Figure 6, New Carbon Doors In-flight

Multiple test flights with ever increasing speed have shown the new doors to be completely locked in the retracted position. No movement, whatsoever has been detected.

The drag reduction seen thus far is less than half of the total to be expected due to the yaw generated by one closed door and one open door.

Measured airspeed at 7,500' has increased from 206 to 208 KTAS.
