Lancair Legacy Canopy Safety Issue

Legacy Project N114TF

Introduction

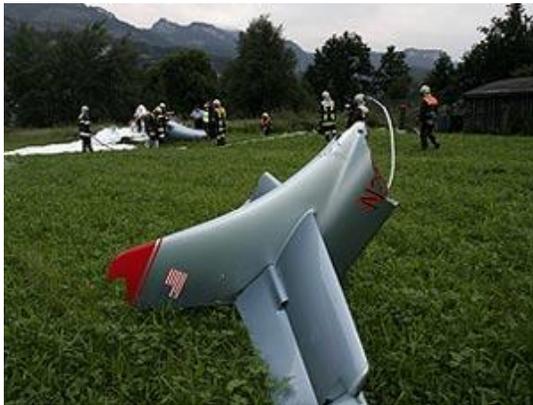
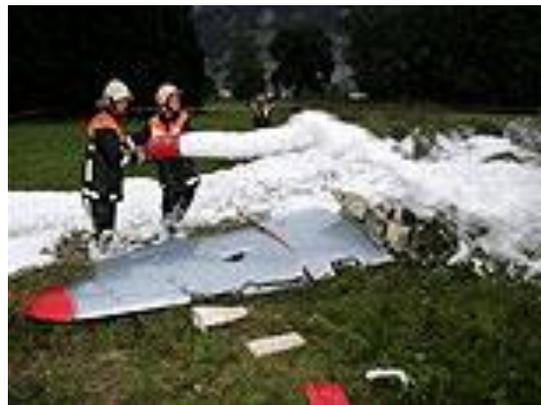
After takeoff the canopy popped open, Wolfgang could not see forward, and the aircraft was very difficult to control. It's unknown if he tried to close the canopy. He reduced power and tried to land directly ahead in fields beyond the runway.

The plane lost the wings on the very hard touch down. The fuselage broke behind the seat and ejected Wolfgang out of the plane. It was a muddy soft grass field and the engine was buried in the mud.

N345MW Wreckage

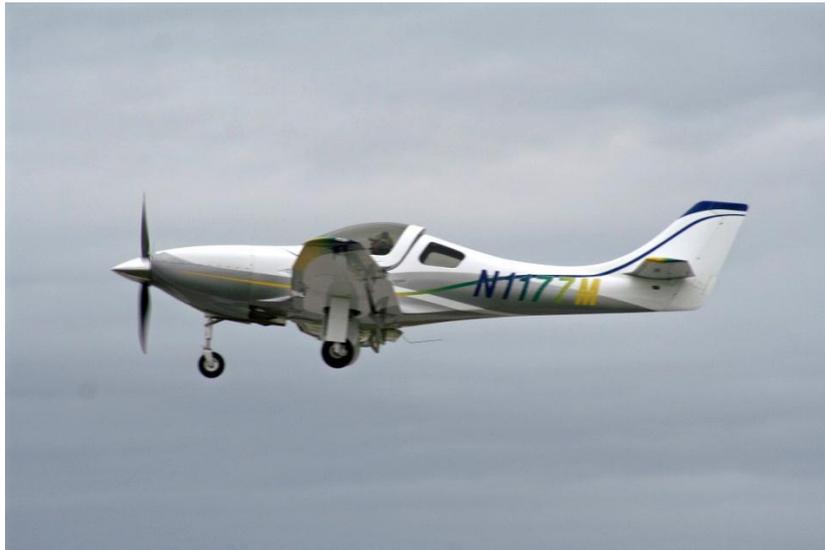
According to witnesses, the pilot was observed having difficulty closing the canopy on the airplane prior to takeoff. During the takeoff climb, a witness said he saw the cockpit canopy moving and believed the pilot was pushing it up and down about 6 to 12 inches. Another witness stated that shortly after takeoff, the engine lost power and the airplane continued straight and level. Another witness stated that she saw a plastic bag float down from the sky shortly after the airplane passed over her location. The bag contained several of the airplane's documents inside of it. The airplane then nosed down about 40 degrees and the left wing dropped as the airplane stalled and collided with the ground. A post-crash fire ensued which consumed part of the engine and the majority of the airframe, including the canopy latching system. Examination of the available wreckage did not reveal any evidence of pre-impact failures or malfunctions. The pilot Gerard Schkolnik, (Aeronautical Engineer, Private, ASEL) age 44, was fatally injured.

Photo of N1177M on takeoff before crash, note open canopy

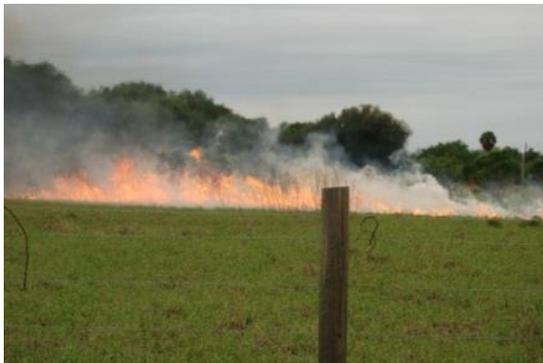
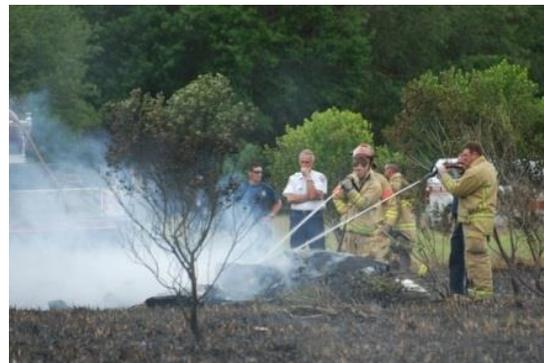
N1177M crash site, wreckage (Photos: The Ledger.com)

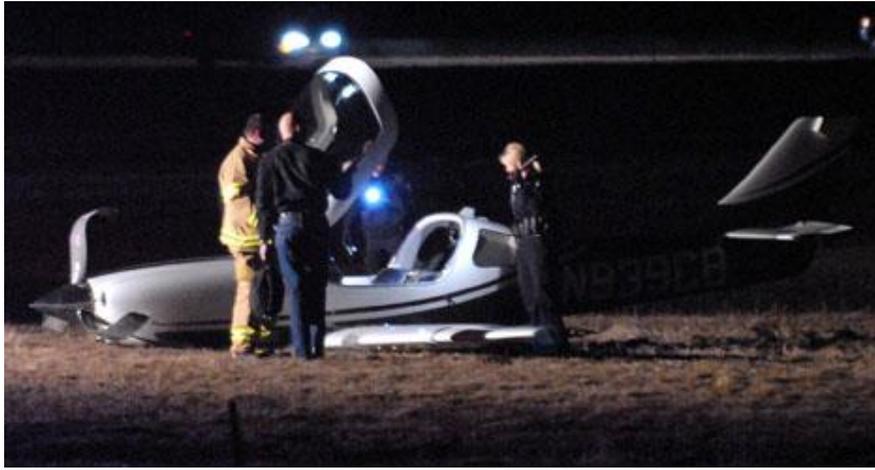
David said on final approach, the canopy opened so far that the airport could be seen between the nose and the forward edge of the open canopy. The view forward was not a sufficient reference to fly from. When looking to the side for reference, the wind blast was so high that it blew his eye glasses off his face. Aircraft landing gear sheared off, skidded through fence posts, significant damage.

N939CB After Open Canopy Crash Landing

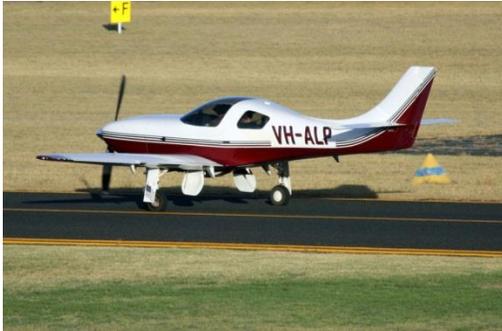
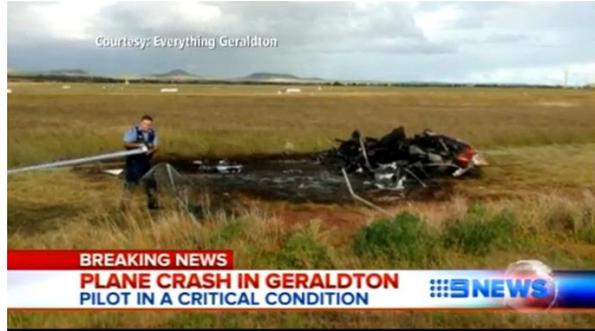
The pilot appeared to be maneuvering for a landing on runway 08 but the aircraft wheels hit a road curb short of the airport perimeter. The aircraft then collided with the perimeter fence and became entangled as it overturned. Shortly after, an intense fire engulfed the aircraft.

VH-ALP Photo and Crash Site

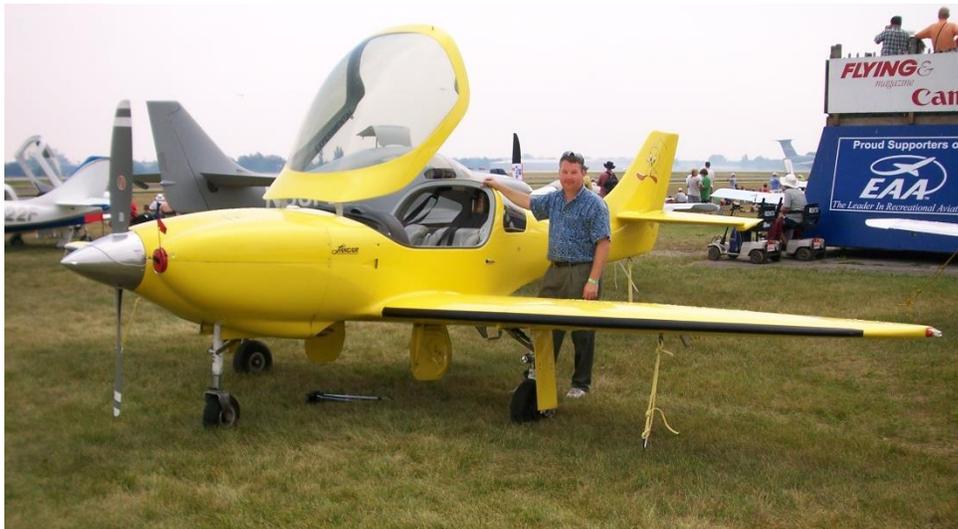
The Lancair Legacy was not designed for flight with the canopy unlatched/open. The Legacy's canopy is hinged at the front with mechanical latching claws on each side of the aft cockpit opening that engage with latching plates on the aft canopy frame. The latching mechanism is engaged and disengaged by a lever between the pilot seats and an exterior control lever on the left side of the fuselage below the canopy. The canopy sits down in its closed position and is latched by lowering the lever between the seats. The design allows the canopy to rest in its closed position without being latched.

Photo of Rob Logan's Tweedy Bird Legacy with Canopy Open
(Rob likely has the highest time Legacy flying)

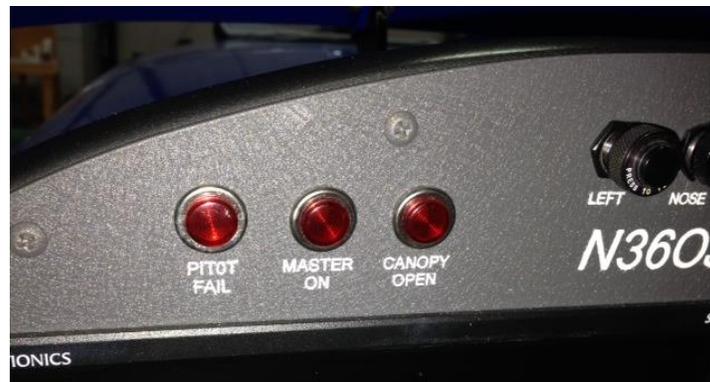
Example Canopy Unsafe Warning Light in Jon Addison's Lancair 360

The risk of takeoff without the canopy latched can be reduced with a prominent annunciator on the instrument panel warning the canopy is in an unsafe configuration – not down and latched.

In this example, a micro switch is positioned so that the canopy alignment guide depresses a micro switch and the latching lever depresses a micro switch when it is down. Both the canopy and lever have to be down in order for the warning light to go out. This same signal can be routed to an EFIS system for annunciation.

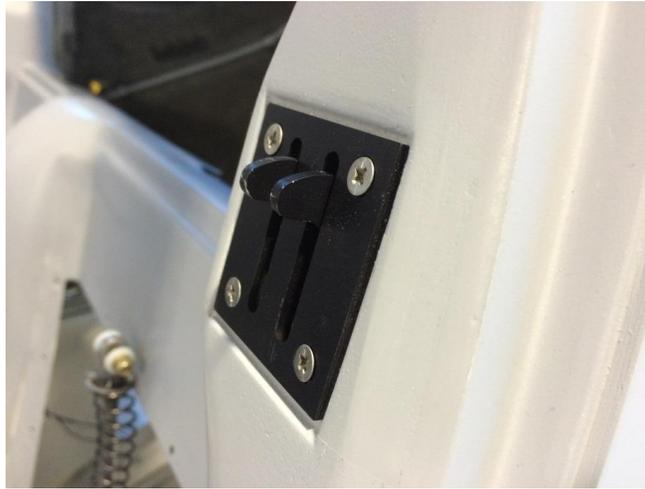
The Canopy Latch Mechanism Modification requires the upper lever stop be moved so that the canopy latching claws remain extended $7/16$ " when the canopy lever is in the fully unlatched position.

Photo of Canopy Latch Claws Modified to Remain Partially Extended
When In Full Canopy Release Position

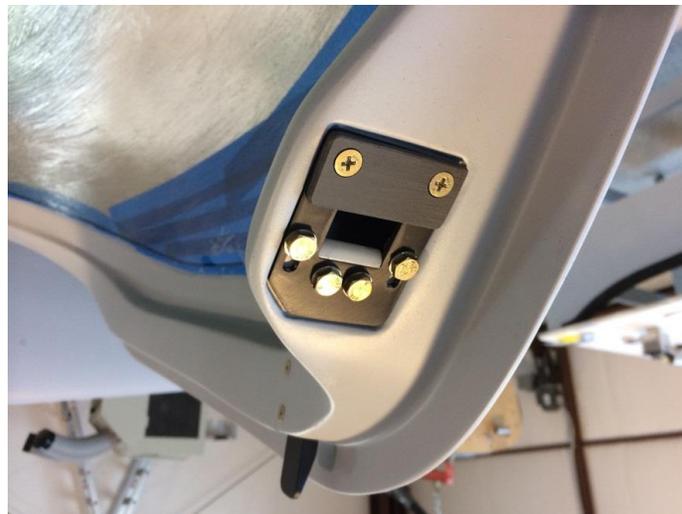
The canopy latching striker plates require installation of 1" x 2" pieces of 1/8" thick Nylon or ABS. The top AN3 hex head bolts are replaced with MS24694 – S54, (10-32) countersunk screws to secure the new "canopy lift plates".

Photo of Canopy Striker Modified with Lift Plate Installed

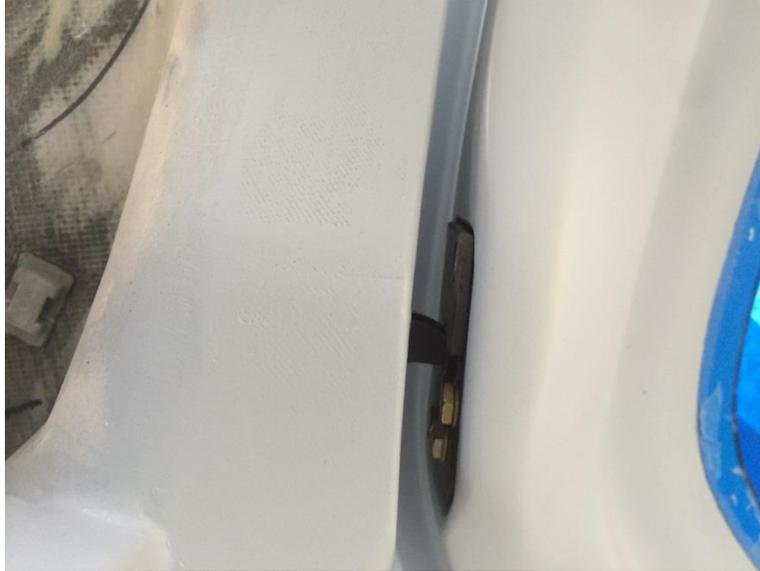
Photo Showing Claws and Striker Plate with Canopy Propped Open by Latch Mod
