Anatomy of a Hydraulic Failure

Hydraulic Fittings Need to be Very Carefully Tightened

(Rev. 2, 3 June 2010)

Fred Moreno, Chris Howden (SAAA Chapter 13)
Laurie Fitzgerald (SAAA Chapter 24)

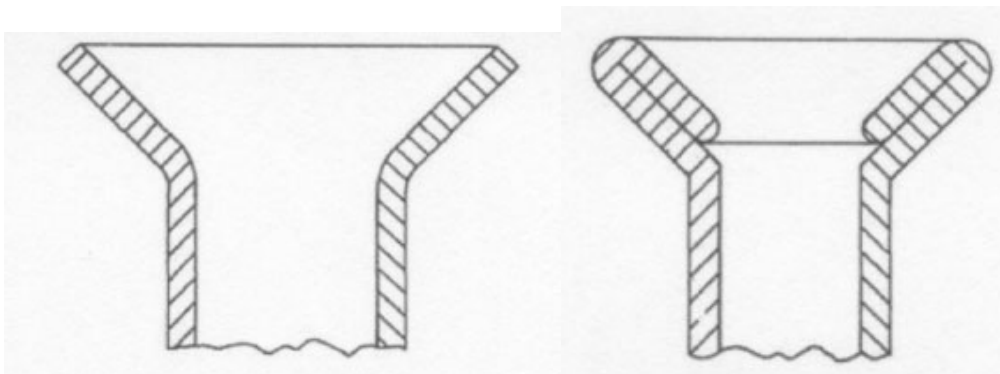
AC 43-13 also specifies that aluminum hydraulic lines of 3/8 inch diameter and below are to be made with double flare ends with single flares being used on larger tubing sizes. See figures below.

Single flare tube end

Double flare tube end

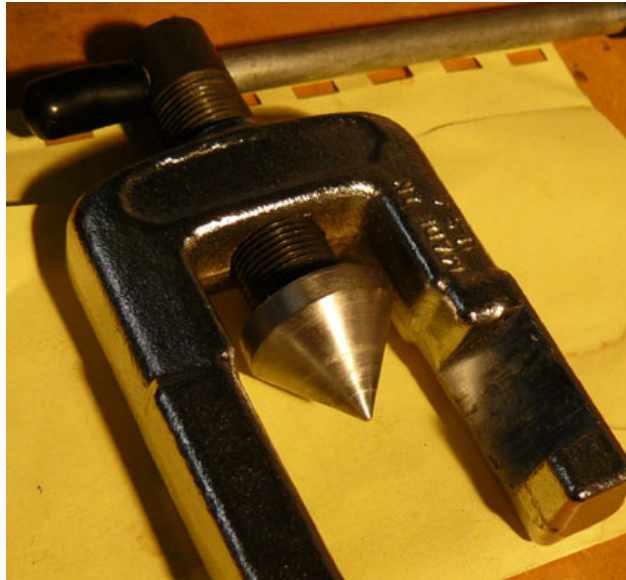
Thirty-seven degree flaring tool

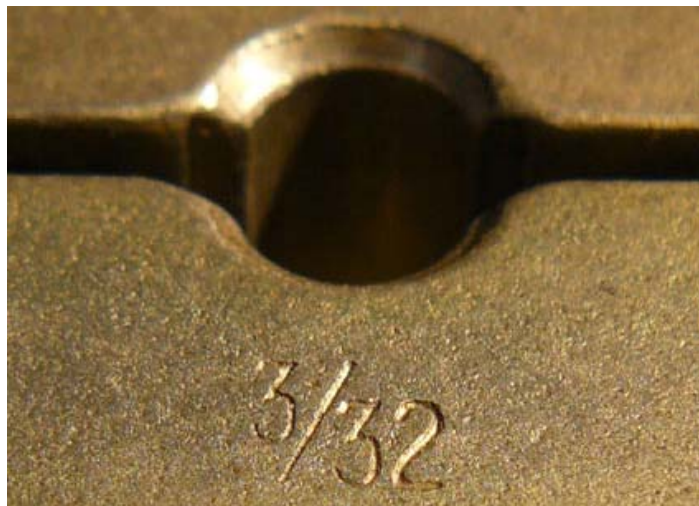
Tube clamp that holds tubing during flaring process

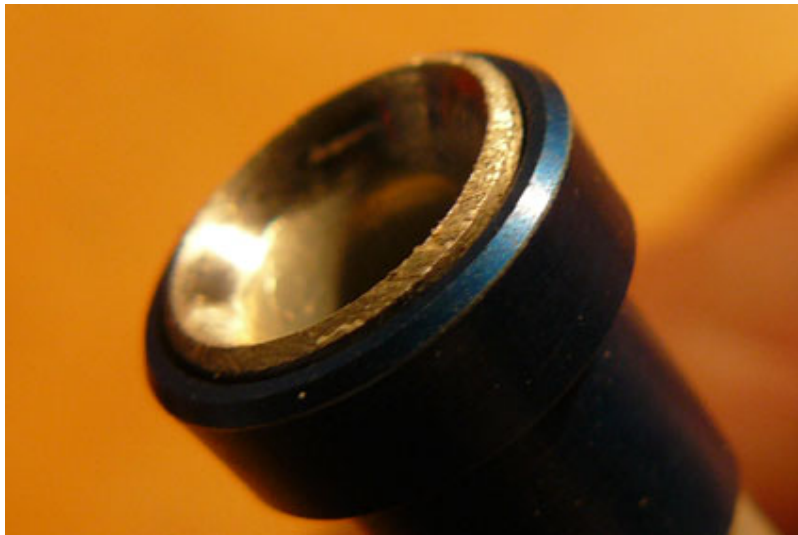
If you prepare the tube end square, deburred, and flare the appropriate length of tubing (3/32 in or about 2.5 mm for our tool), you should get an assembly that looks like this.

New tube flare, never used, with proper tube flare length

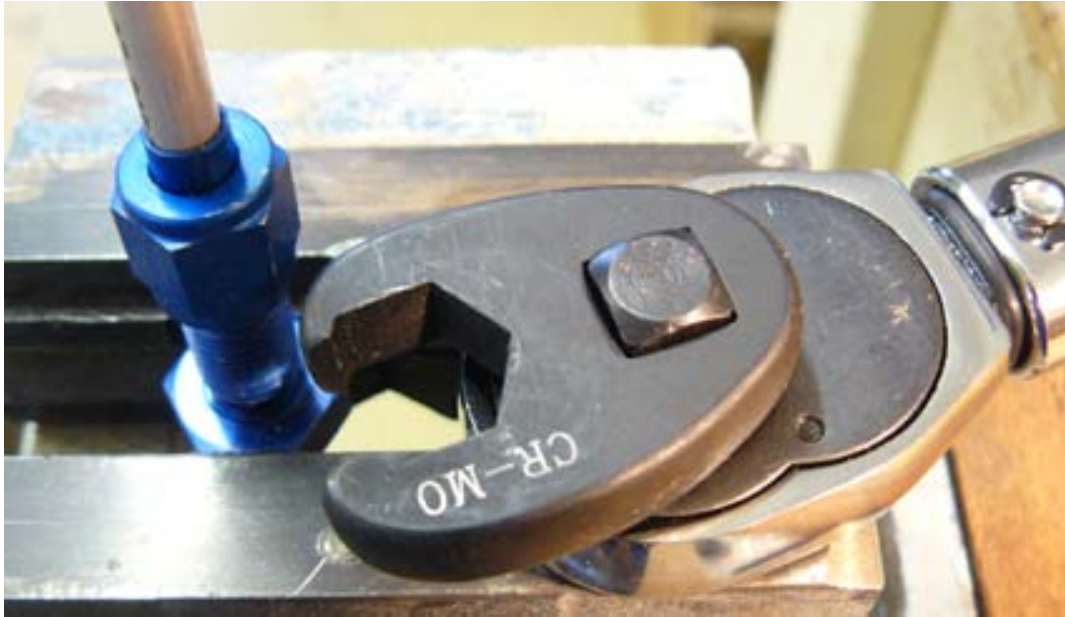
In our first tests, we made up a flared 1/4 inch aluminium tube end, added an AN 818 nut and ferrule and then tightened onto a bulkhead fitting at 100% of recommended torque (50-65 in lbs. or about 5 ft lbs.). We used a new Kinchrome 3/8 drive torque wrench with a fresh calibration certificate driving the nut through a crow foot open end adapter as shown in the figure below.

Three-eighths drive torque wrench with crow foot to drive AN 818 nut
