# The Outback Gear and Drag

9-29-2009, C.Zavatson

In the on-going effort to reduce drag, the focus turns to an issue unique to the outback gear seen on the Lancair 320/360.

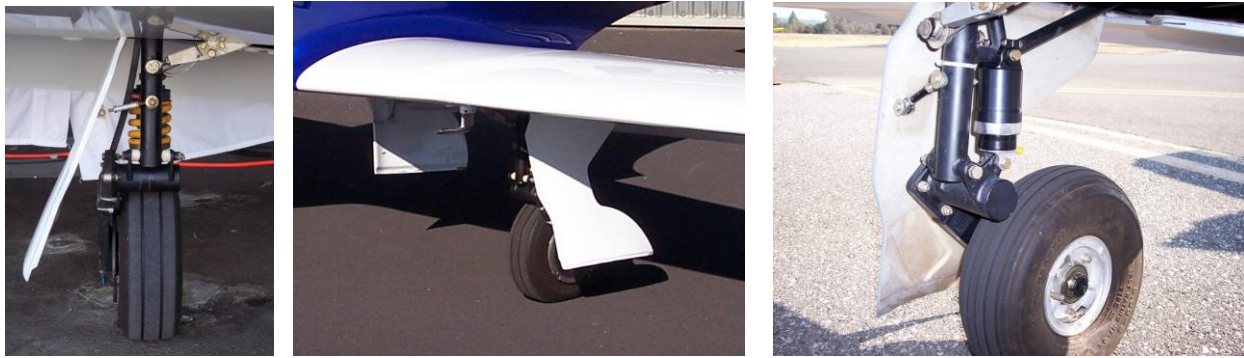
The “Outback Gear” replaced the 11.400-5 wheels with the larger and more common 5.00-5 wheels. The outback gear also brought with it changes to the landing gear doors that had some unintended consequences. The doors switched from a three piece design to a two-piece. The outback gear doors are larger and have a good deal of camber. They must ‘bump out to clear the larger wheel assembly. This introduced a few problems. The highly cambered door created a large downward force on the doors. As a two piece design, the doors depend heavily on the inner gear door cylinder to keep both doors retracted. The outboard doors are very long and have a narrow cross section near the actuation attach point. The inner gear door overlaps the outboard gear door when retracted.

Figure 1, Photos of the “Outback Gear”
