FAA's War on Jugs: An Update

Yikes! It's far worse than I expected, and it must be stopped.

by Mike Busch A&P/IA <mike.busch@cessna.org>

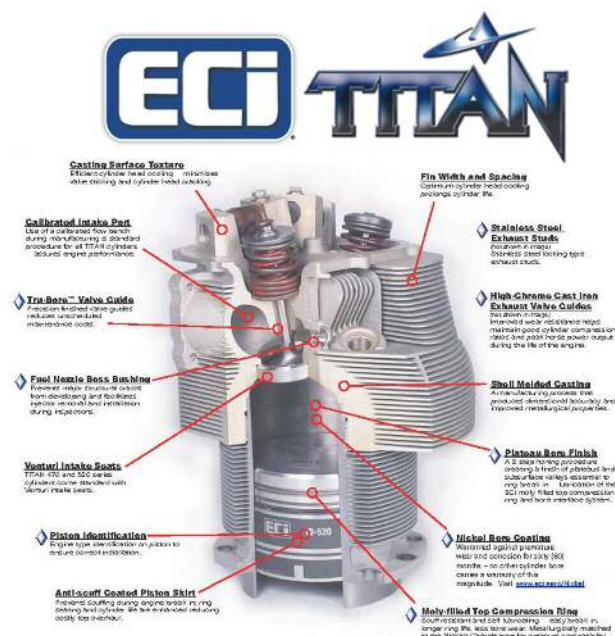
Caption: Figure 1—The FAA wants to condemn 36,000 ECi TITAN cylinders on 6,000 Continental 520- and 550-series engines, costing owners an estimated \$82.6 million.

The FAA issued its Notice of Proposed Rulemaking (NPRM) for the ECi TITAN AD on August 12, 2013, and when I read it I was absolutely floored. It turns out that the proposed AD would actually euthanize 36,000 cylinders on 6,000 Continental 520- and 550-series engines at an FAA-estimated cost to owners of \$82.6 million, making it one of the most costly General Aviation ADs in history.

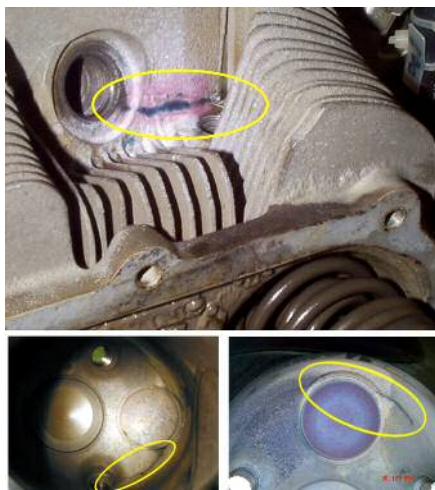
Caption: *Figure 2—Cylinder head cracks are very common, and roughly 99.9% of them are benign.*

A recent review by a large well-known cylinder shop of 700 cylinders sent in for overhaul found that 75% of the cylinders had head cracks. About 40% of those cracks originated at one of the spark plug bosses, 20% of them were in the exhaust ports, 14% in the exhaust valve seat bosses, 11% in the fuel nozzle bosses, and the remaining 15% in various other places. None of these cracks were detected until the cylinders were removed. None of them caused any sort of performance problem or presented any sort of safety issue. The cylinders worked just fine despite the cracks.

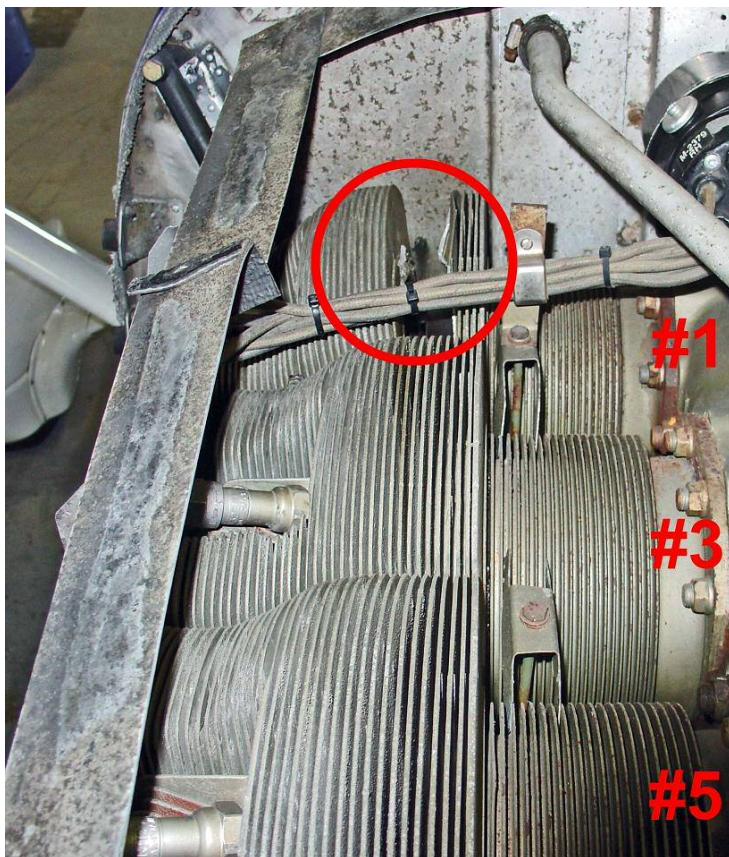
Caption: **Figure 3**—Head-to-barrel separations are rare. This one shut down a Continental factory cylinder in an O-470-U engine in a Cessna 182. The engine continued to run on five cylinders and the pilot landed without incident.

Cracks in the head-to-barrel junction area are exceedingly rare, representing only a small fraction of a percent of head cracks. Actual head separations are even rarer. According to the FAA's own Service Difficulty Report database, there were only 29 reports of head-to-barrel separations of ECi cylinders (out of a population of more than 30,000), and of those only 21 could be verified. That's a failure rate of less than 0.1%.

Consider what happens when a cylinder on a Continental 520/550 engine suffers a head separation: The cylinder goes to zero compression and shuts down, leaving the engine capable of producing about 80% power. The head separates from the barrel by one inch or less, held in place by the exhaust and induction manifolds. The separation stops the cylinder's valves from opening so there's no uncontained exhaust and no induction leak. The barrel remains firmly attached to the crankcase, and the piston happily continues to reciprocate in the zero-compression environment, with only a tiny loss of engine oil.

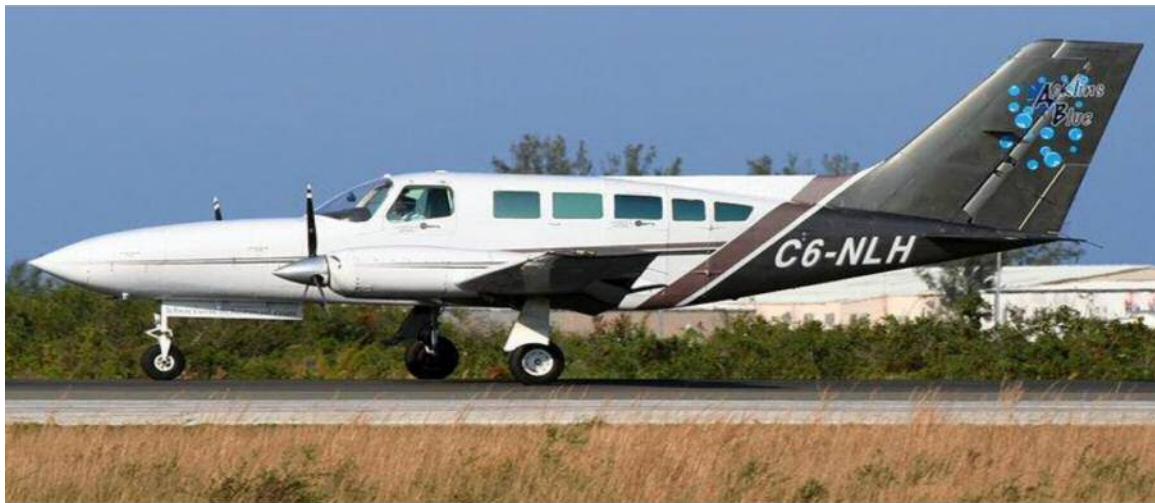
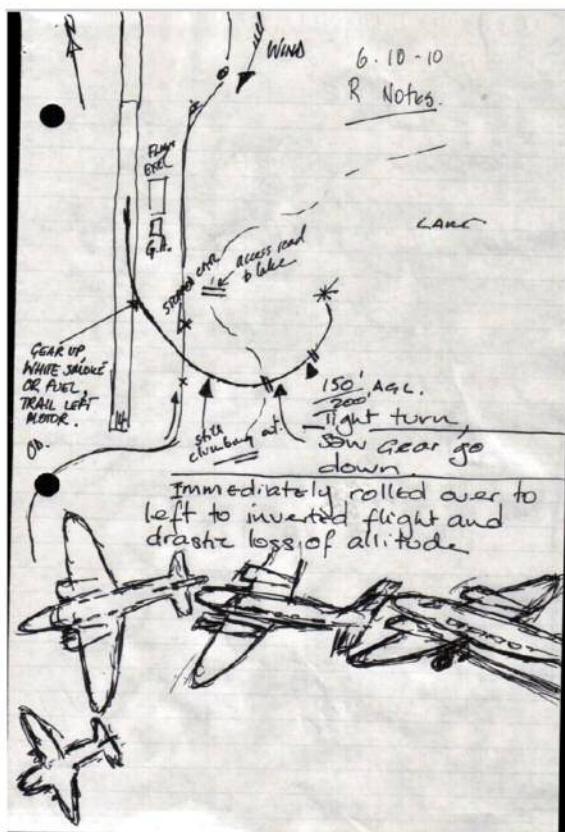
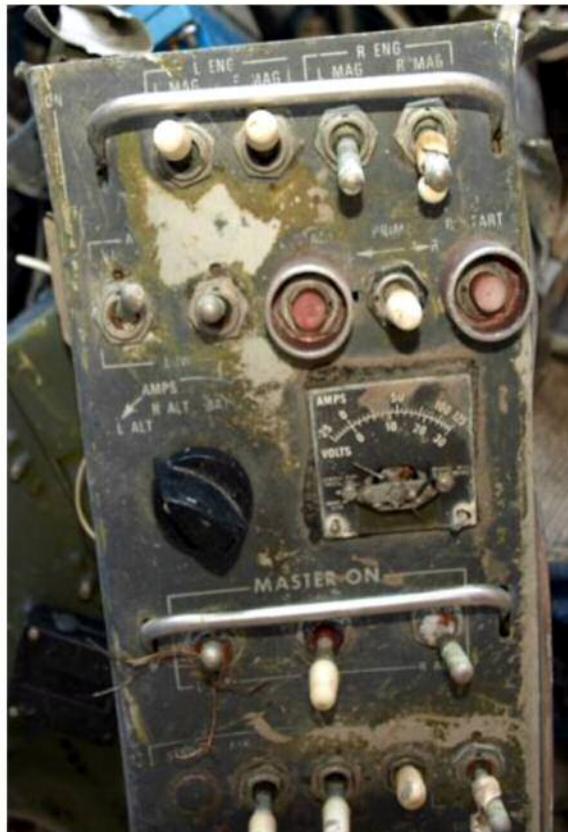
Caption: Figure 4—The Bahamian Cessna 402C crashed after takeoff from Nassau, Bahamas, killing all nine aboard. The aircraft suffered a head separation on the left engine, which continued running and producing power. The pilot shut down the right (wrong!) engine, didn't feather the prop, attempted a steep left turnback maneuver at 200' AGL, and extended the landing gear. The airplane was 500 to 700 pounds over max gross.

Briefly what happened is that the Cessna 402C departed from Nassau, Bahamas with 9 people and a whole lot of baggage aboard. The aircraft was at least 500 pounds over gross and possibly as much as 700 pounds over gross. The 12,000-hour PIC took exceptionally long to perform his pre-takeoff runup checks, and some witnesses indicated there was some backfiring during the runup. The PIC then made an intersection takeoff, and upon application of takeoff power the left engine immediately started emitting white smoke. The takeoff run was about 4,000 feet (compared to the expected 2,200 feet). The tower radioed the aircraft that they were trailing smoke from the left engine. The pilot stated his intention to return to the airport and land on runway 27. The aircraft commenced a left turn at an estimated altitude of 150 to 200 feet. The landing gear was re-extended and the left turn tightened until the bank angle was 90 degrees, whereupon the aircraft cartwheeled into a lake.

Post-accident investigation of the left engine revealed that the #2 cylinder had suffered a head-to-barrel separation. The engine was clearly making partial power on five cylinders. It appears that the pilot shut down the RIGHT engine by mistake; both mag switches and the alternator switch for the RIGHT engine were found in the OFF position, while the mag switches and alternator switch for the LEFT engine were all in the ON position. Neither propeller was feathered and the landing gear was extended. Inexplicably, both fuel selector levers were found to be in the OFF position.

The left engine's #2 cylinder was examined extensively. It was indeed an ECi cylinder. However—and this is crucial—it was NOT a new-manufacture TITAN cylinder, but rather an overhauled continued-time cylinder (sold by ECi under the FREEDOM brand name) in which the barrel and head had been de-mated and then re-mated by AEC. As is typical of continued-time overhauled cylinders, the total time-in-service of the cylinder head was not tracked or recorded, but it was undoubtedly way past Continental's recommended TBO. What we do know is that the cylinder was originally manufactured in 2006, overhauled by ECi in 2008, then repaired at least once after that (since it's ECi exhaust valve and seat was found to have been replaced by exhaust valves and seats from Superior Air Parts).

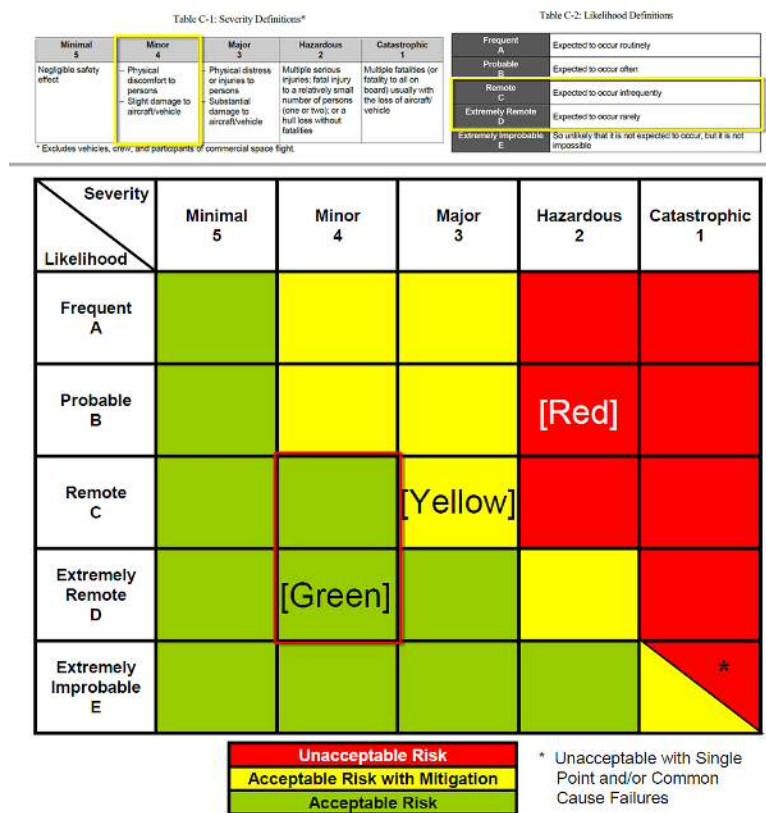
Caption: **Figure 5**— Using the FAA's own risk assessment algorithm (FAA Order 8040.4A), head-to-barrel separations are clearly an "Acceptable Risk" for which no mitigation is necessary. So why are they proposing this horrible AD?

The FAA's own published Safety Risk Management Policy (Order 8040.4A) provides a specific algorithm and matrix for assessing whether a particular safety risk is acceptable or unacceptable, based on both the likelihood and severity of the risk involved. The data shows clearly that the likelihood of head-to-barrel separations is "remote" (less than .001) and the severity is either "minimal" or "minor" (because the engine doesn't quit and nobody gets hurt). If you plug this into the FAA's own risk matrix, you'll find that head separations represent an "acceptable risk" for which no mitigation is necessary.
